ITB10-015

## **VOLUNTARY SERVICE CAMPAIGN 2010 G37 WITH NAVI; RADIO SEEK FUNCTION**

**CAMPAIGN ID #:** P0308**APPLIED VEHICLE:** 2010 G37 Sedan, Coupe, & Convertible (V36, CV36, & HV36)**Check Service COMM to confirm campaign eligibility.**

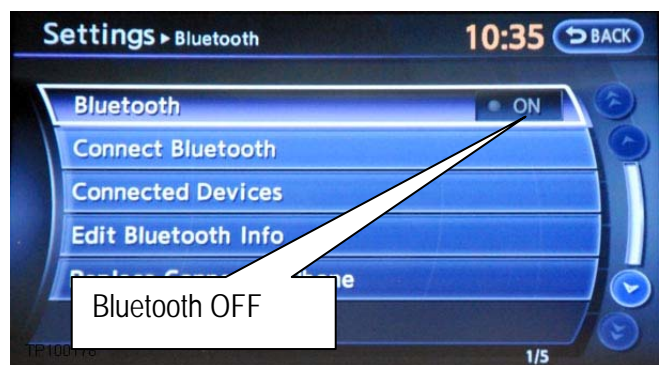
Figure 3

7. The “ON” indicator turns off (grayed out).

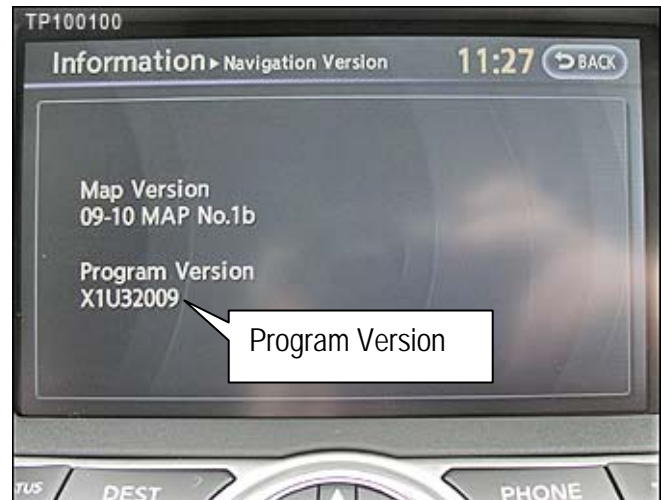
Figure 2

6. Make sure Program Version is X1U32009.

**NOTE:** If Program Version is X1U32013, reprogramming is not needed:

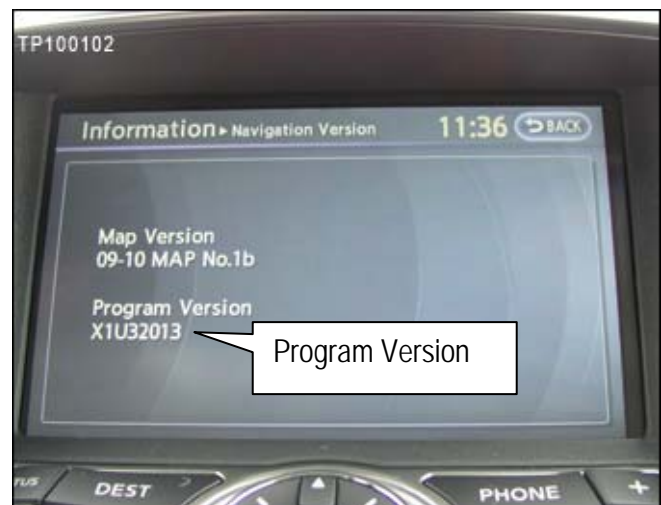
Figure 6

- d. Make sure Program Version is X1U32013.
- f. Proceed to C. Enable Bluetooth® Function.

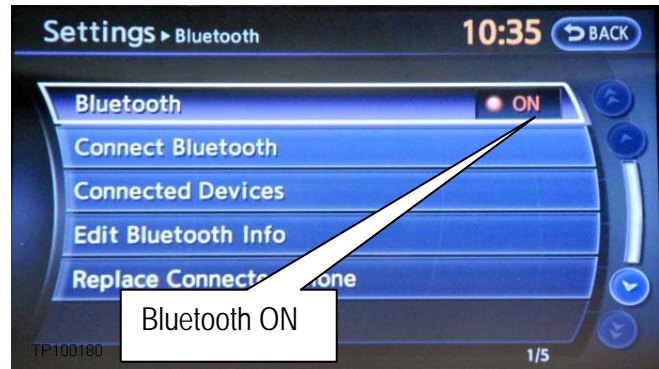
Figure 3

4. The "ON" indicator turns on (shows in orange).
