Classification:
BT10-037

Reference:
ITB10-069

G37 CONVERTIBLE; HEADLINING SERVICE INFORMATION

APPLIED VEHICLE: 2009 – 2011 G37 Convertible (HV36)

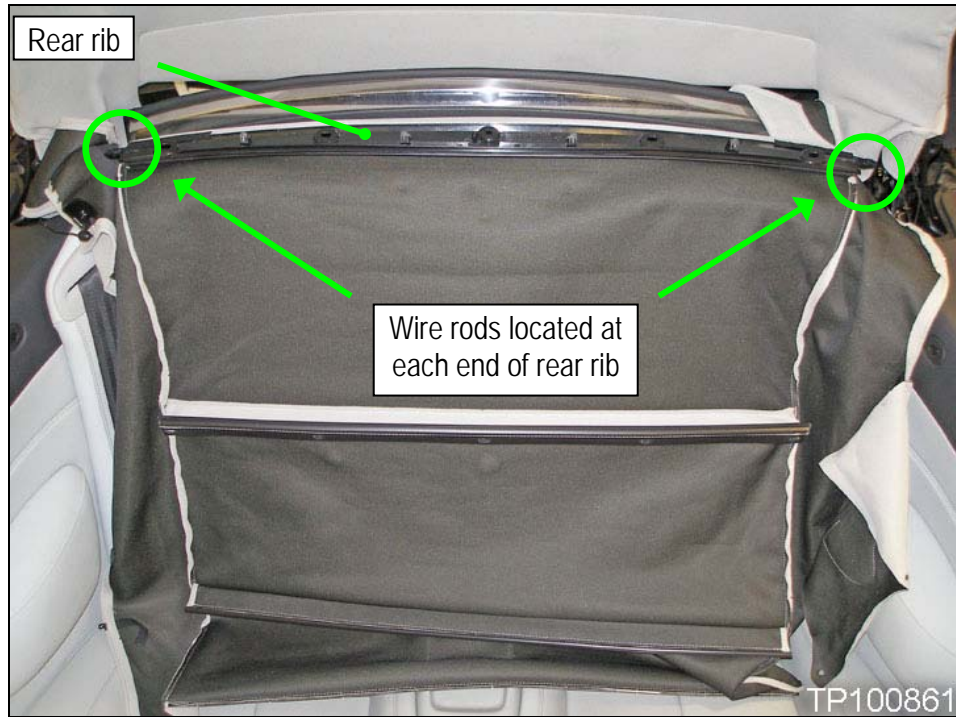
Headlining, removed

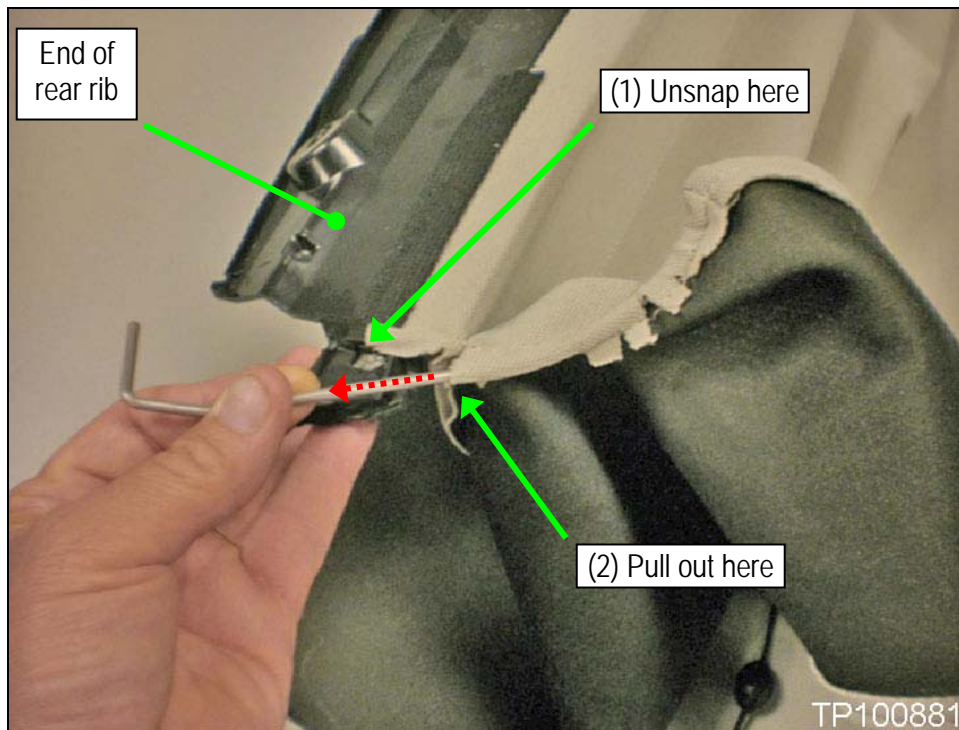
Remove wire rods from old headlining

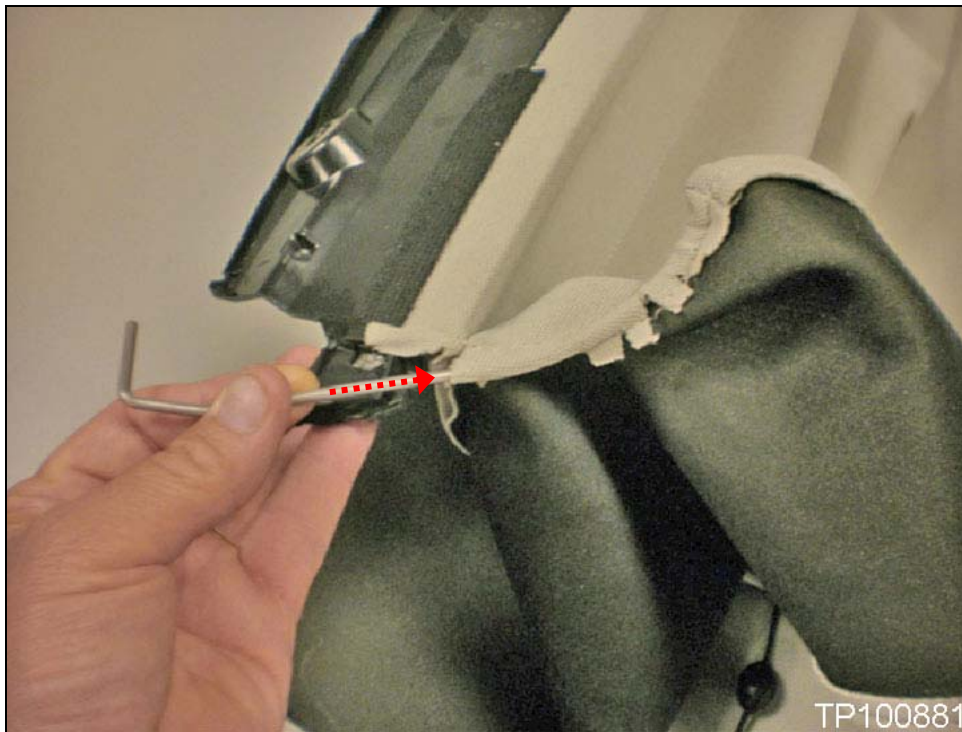
Carefully insert wire rods in new headlining

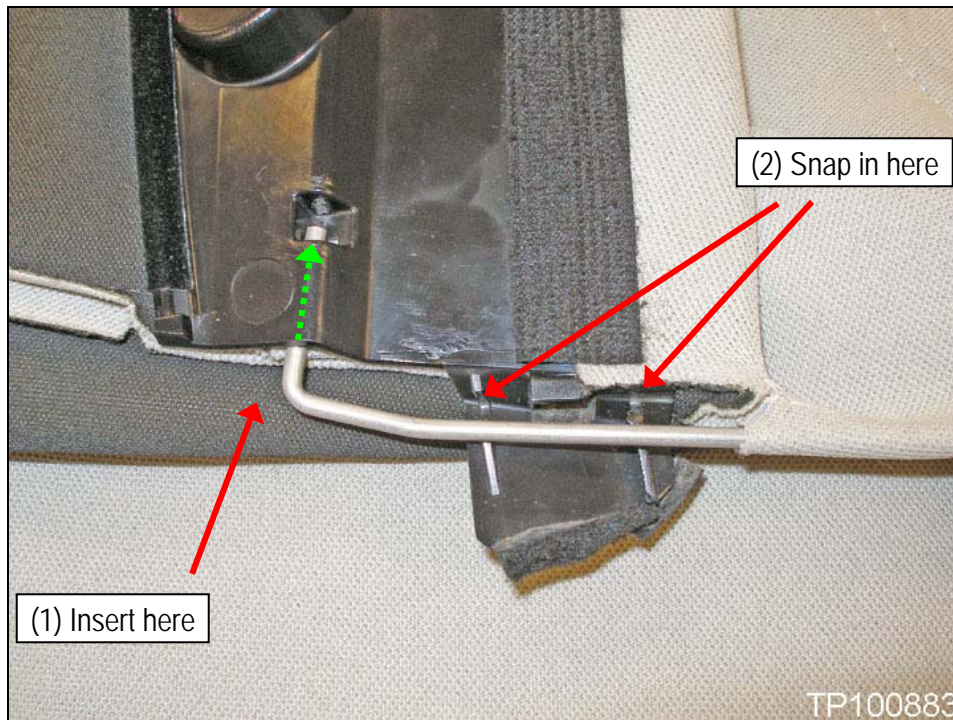
Fasten wire rods to rear rib
