ST14-006

INFINITI; HITACHI BRAND POWER STEERING GEAR SERVICE INFORMATION

APPLIED COMPONENT: Vehicles with Hitachi brand power steering gear only

Power Steering Gear Inspection

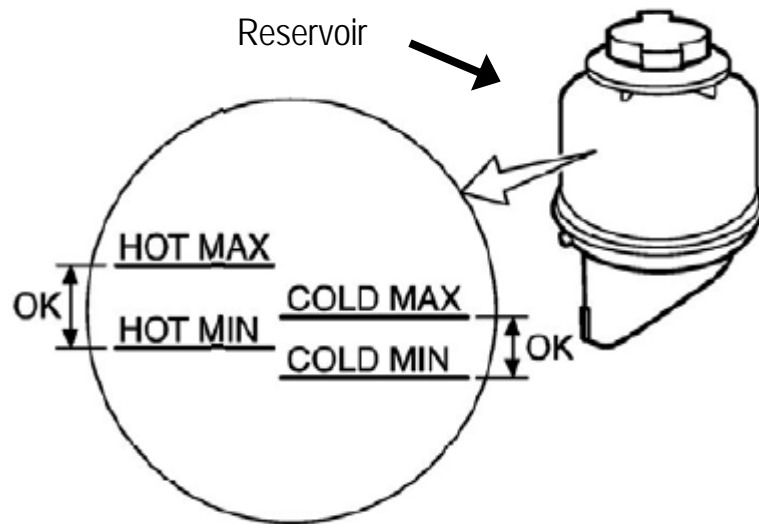
1. Verify the fluid level in the reservoir is within OK (normal) cold or hot range, as it applies.

Figure 2: Make sure the fluid level is in OK (normal) range.

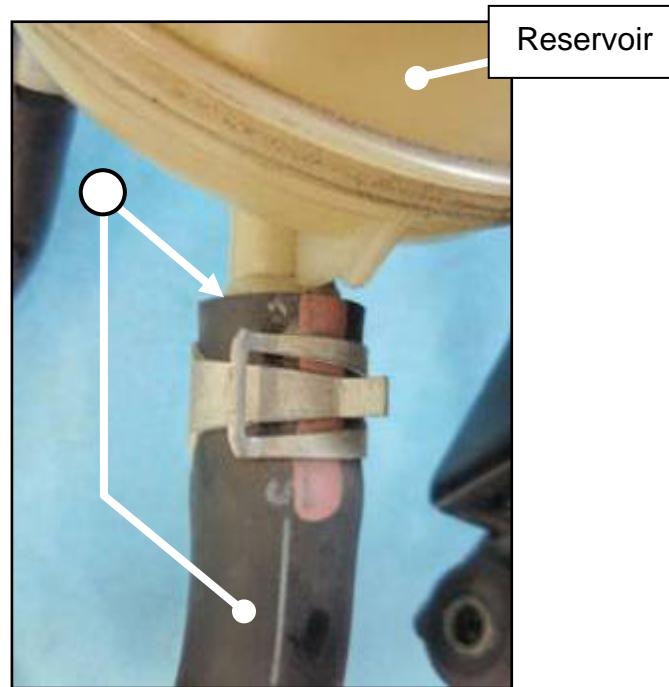
2. If fluid level is lower than specification, check for leaks at all hose fittings for the power steering system.
- For sample locations of inspection, see Figure 3, 4, and 5 below.

Figure 3: Inspect where noted.

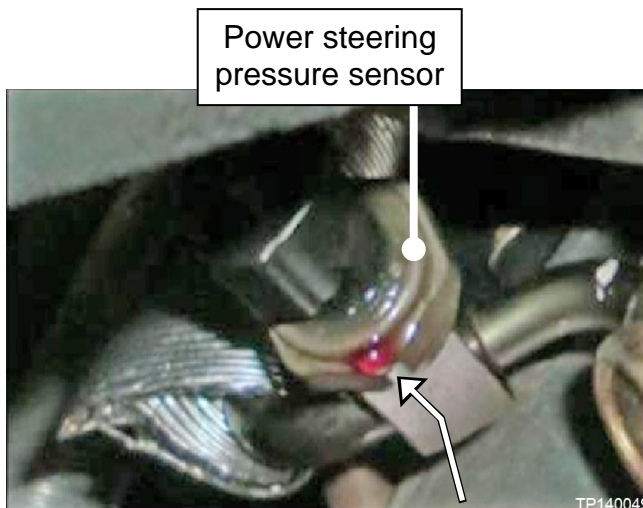
Figure 4: Presence of **RED** fluid indicates a power steering fluid leak.

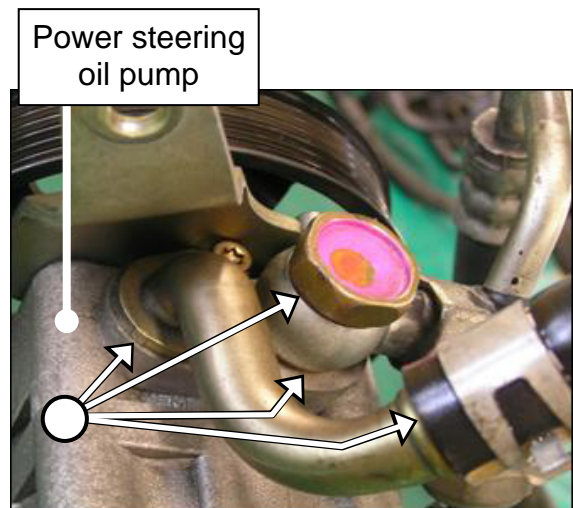
Figure 5: Inspect where noted.

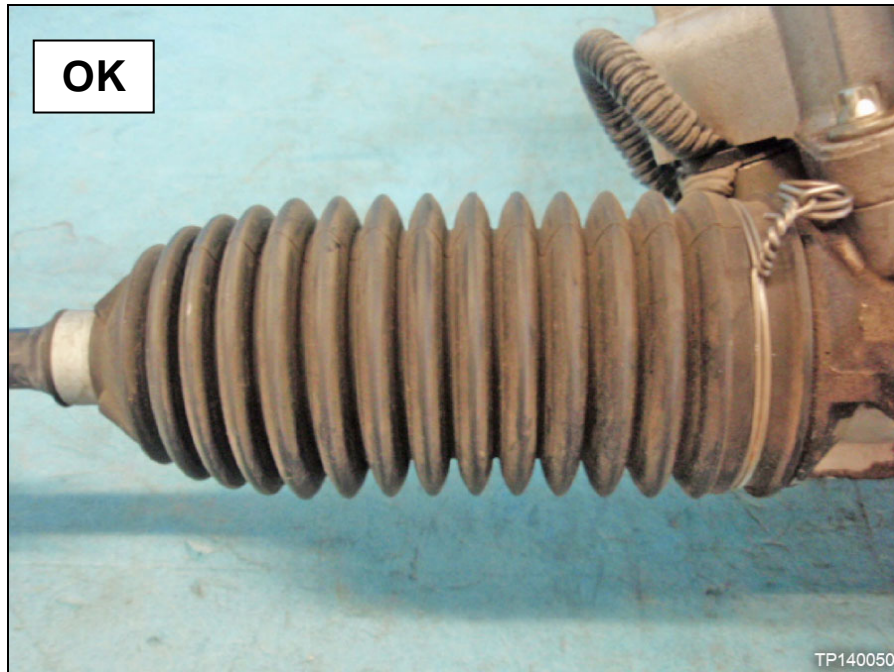
3. If no leakage found at any hose fittings, inspect the steering rack dust covers (boots).
4. If the boots appear similar to the example in Figure 6 below, the steering rack is not leaking.
 - a. Do **NOT** replace the steering rack.
 - b. Clean off any oil/grease residue on the steering rack (see page 7-8).
 - c. Inspection and repairs are complete.

Figure 6: Example of no leaks inside the boot. Boot is dry, dusty.

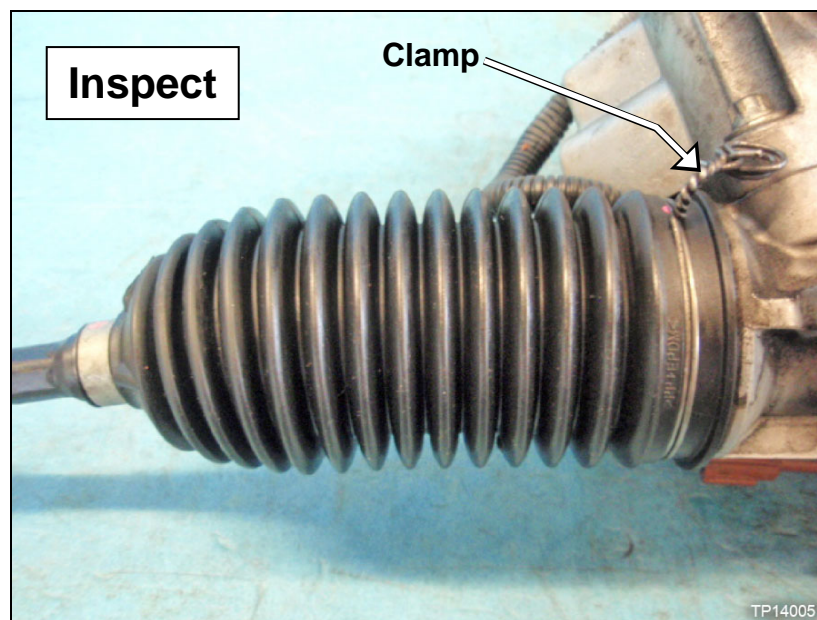
5. If a boot appears similar to the example in Figure 7 below, the steering rack may be leaking. Go to step 6.

Figure 7: Example of a possible leak inside a boot. Fluid permeates the boot, giving it a dark, shiny black appearance.

6. Remove the dust cover clamps (clamp), pull the boots back, and then inspect for fluid and fluid color inside (see Figure 8).
 - See page 4, Figure 7 for example of boot clamp location.
 - Determine color easily by dabbing the fluid with a cotton swab or similar white item.

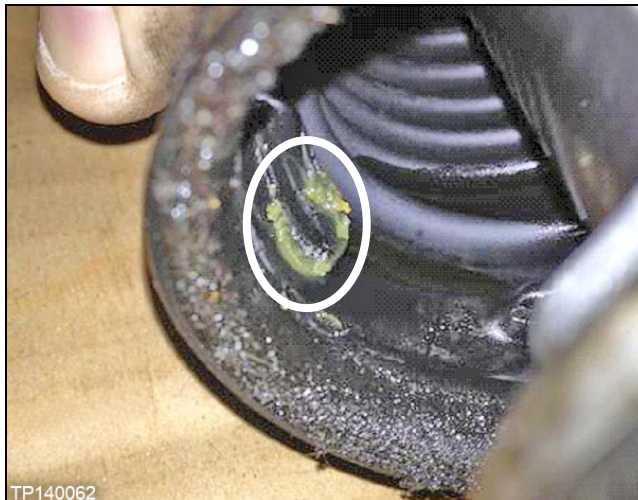
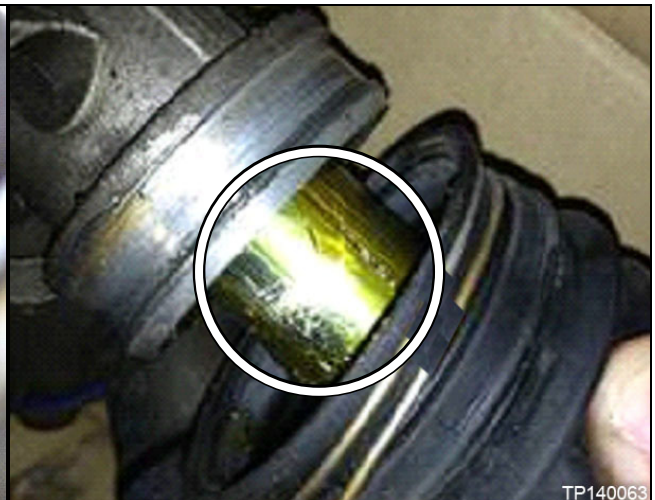
7. If a thick greasy substance is found in either boot and is **YELLOW** in color, the steering rack is not leaking (see Figure 9 and 10 below).
 - a. Do **NOT** replace the steering rack. It is NOT leaking.
 - A **YELLOW** colored substance is an indication of assembly lube. This is OK.
 - See example photos of non-leaking steering racks on the page 7 and 8.
 - b. Clean off all oil/grease residue on the steering rack and on the inside of the boots.

- c. Reinstall both boots and replace the clamps with new ones (see **PARTS INFORMATION**).
Stop here: Inspection is complete.
 - Refer to the Electronic Service Manual (ESM), section ST-Steering System, for installation/replacement information.

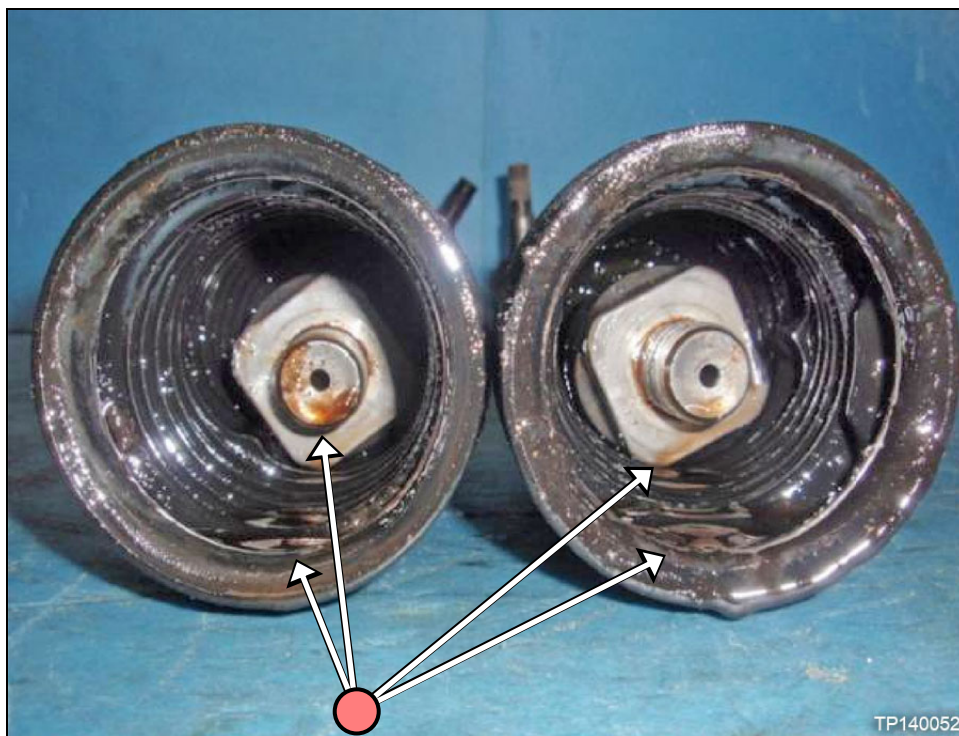
8. If fluid is found in the boot and is **RED** in color, the steering rack is leaking (see Figure 11).

NOTE: The inner and outer sockets (tie rods) with boots in Figure 11 were removed for easier viewing. The tie rods do not need to be removed for inspection.

Figure 11: If fluid is **red** in color, the steering rack is leaking.

- a. Replace the steering rack.
- b. Refer to the Electronic Service Manual (ESM), section ST-Steering System, for installation/replacement information.

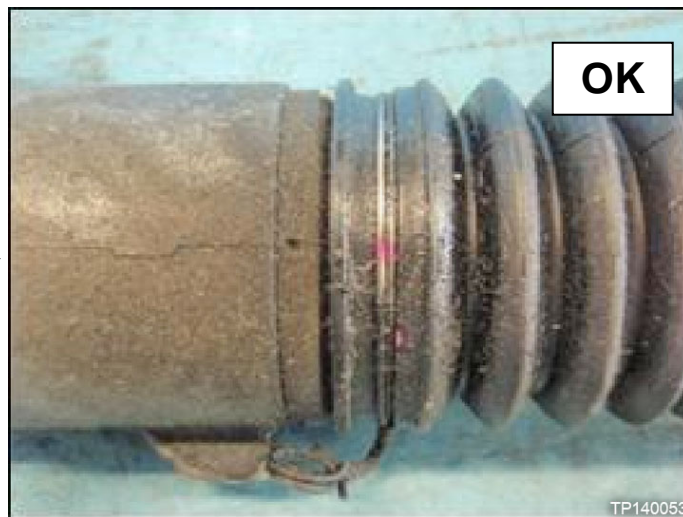
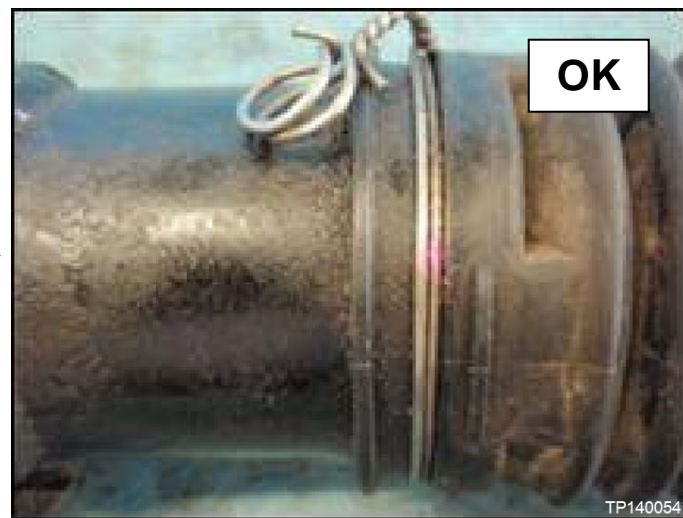
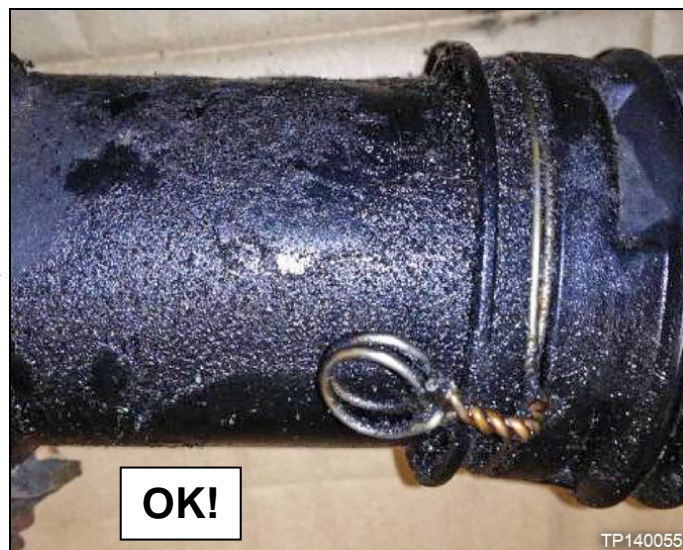
The following pictures show steering racks that are NOT leaking:

Figure 14. Yes, the steering rack above is OK (not leaking power steering fluid). The extra greasy appearance was caused by an excessive amount of assembly lube.

Boot-to-gear
housing area:
Clean off
all residue

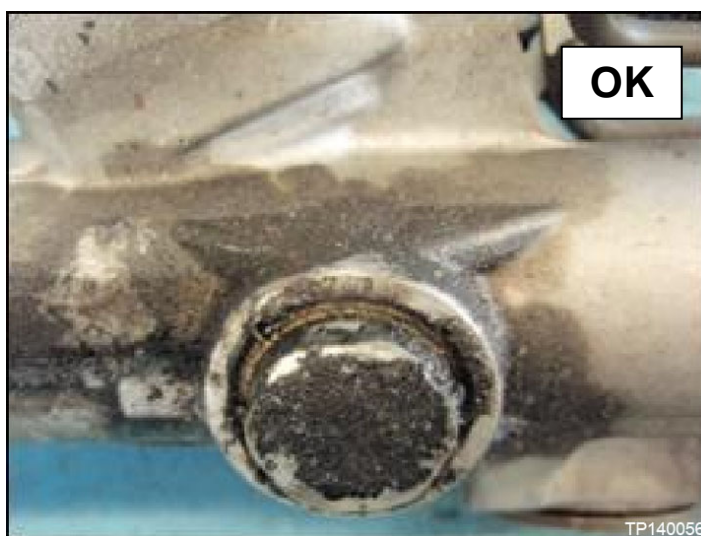
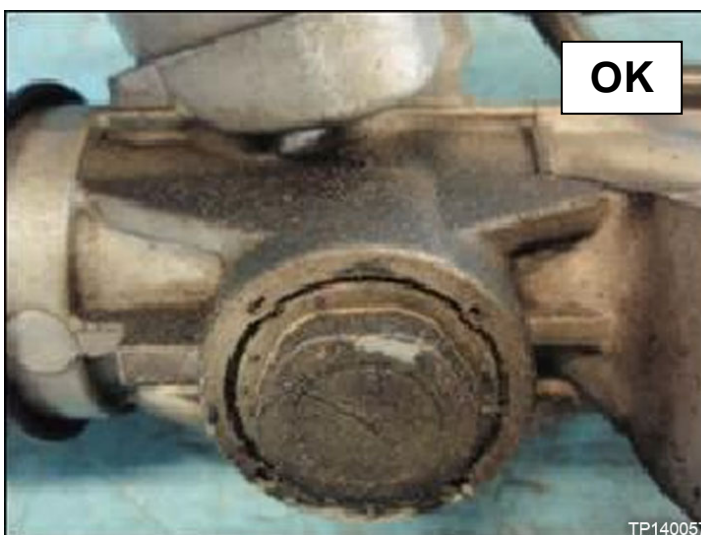
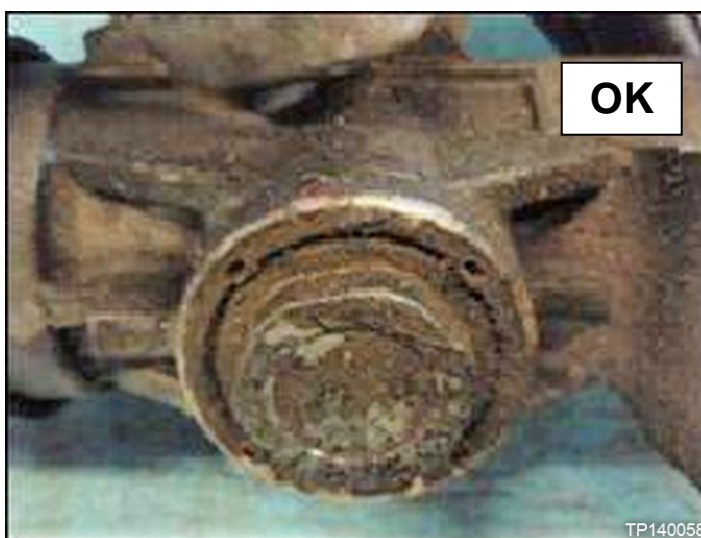
The following pictures show steering racks that are NOT leaking:

Adjusting
screw area:
Clean off
all residue
