ITB10-015

## **VOLUNTARY SERVICE CAMPAIGN 2010 G37 WITH NAVI; RADIO SEEK FUNCTION**

**CAMPAIGN ID #:** P0308**APPLIED VEHICLE:** 2010 G37 Sedan, Coupe, & Convertible (V36, CV36, & HV36)**Check Service COMM to confirm campaign eligibility.**

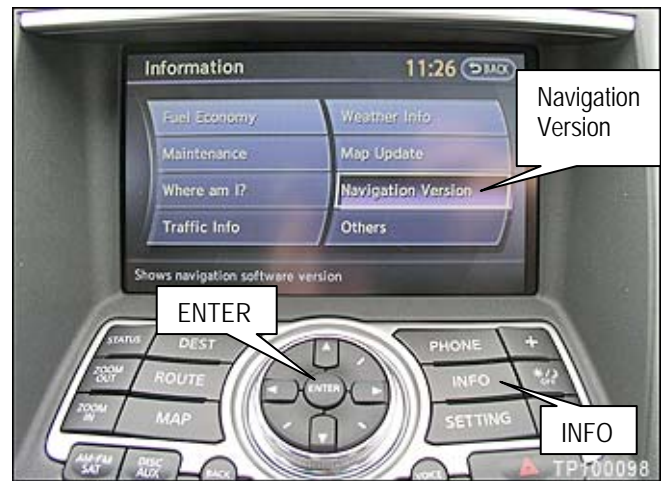
Figure 1

6. Make sure Program Version is X1U32009.

**NOTE:** If Program Version is X1U32013, reprogramming is not needed:

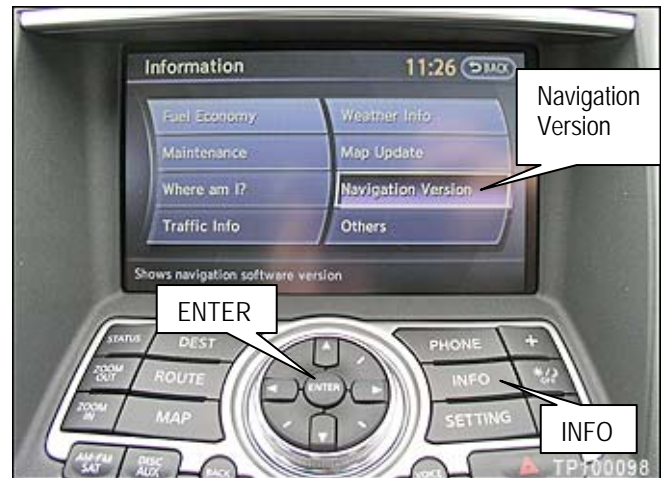
Figure 5

- d. Make sure Program Version is X1U32013.
- f. Proceed to C. Enable Bluetooth® Function.
