EL10-042c

ITB10-066c

August 31, 2011

NAVIGATION / BLUETOOTH / VOICE RECOGNITION ISSUES

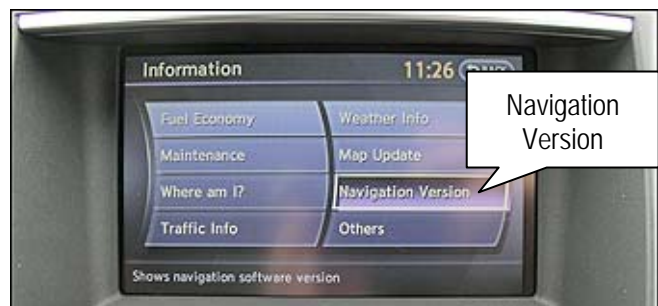
Figure 1

5. Select **Navigation Version** on the display screen.

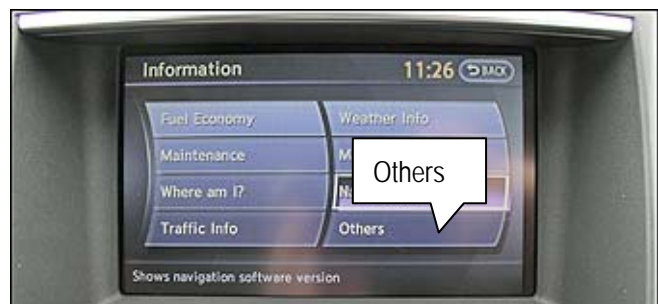
Figure 2

NOTE: On some vehicles you will need to select **Others** to find **Navigation Version**.

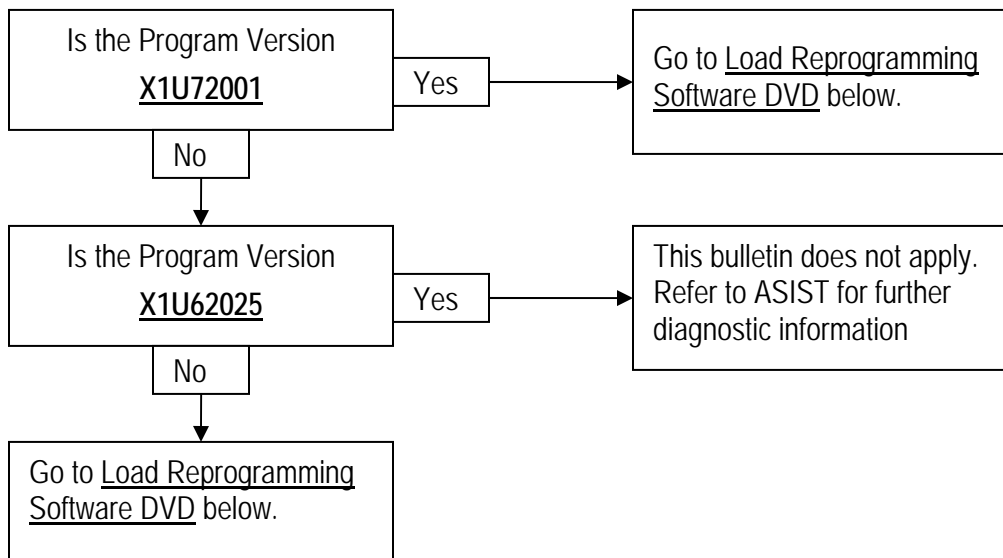
Figure 3

6. Check the **Program Version**.

7. Refer to the Flow Chart below.

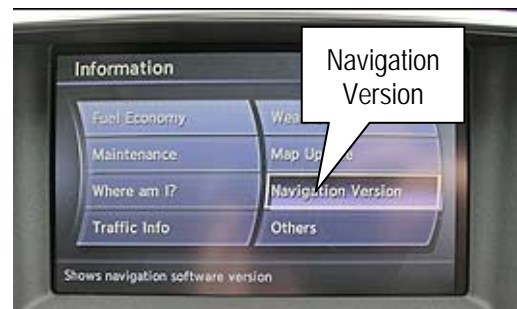
Figure 5

- b. Select **Navigation Version** on the display screen.

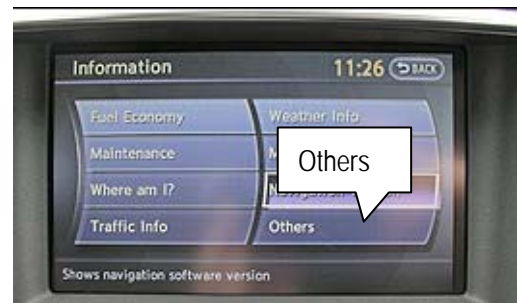
Figure 6

NOTE: On some vehicles you will need to select **Others** to find **Navigation Version**.

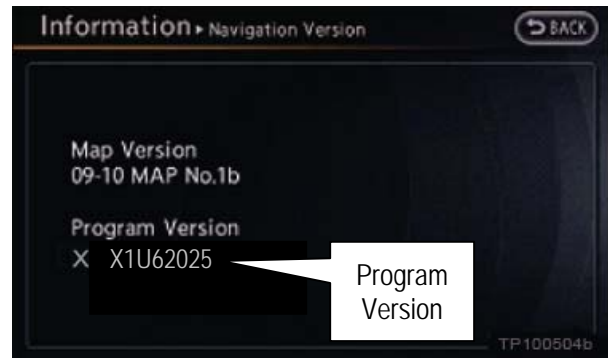
Figure 7

- c. The Program Version should be **X1U62025**.
- If the Program Version is not X1U62025, perform the Load Reprogramming Software DVD procedure again.
