EL11-017d ITB11-040d February 2, 2012

BLUETOOTH® PHONE SOUND QUALITY

APPLIED VEHICLES: 2010-2011 EX35 (J50), FX35/FX50 (S51), G37 Convertible (HV36), G37 Coupe

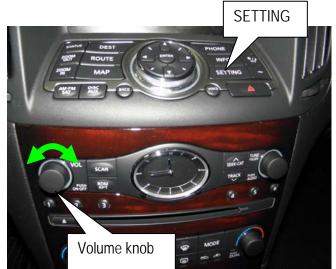
Figure 13

- 25. Put the AV system into System Diagnostic Mode.
 - a. Press and hold the SETTING button.
 - b. While holding the SETTING button, turn the volume control knob 40 clicks or more.
 - The volume control knob can be turned either direction.
 - When the system goes into the System Diagnostic Menu, the screen in Figure 14 will display.
